Pressure and Venting Tests

Lutz Lilje

4.3.2008

Motivation for the Module Crash Test

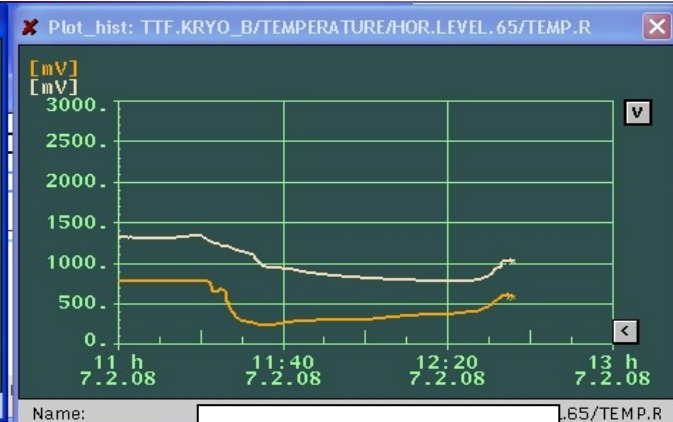
Raum 2 / Cavity-Vacuum:

- Cavity stable at 2K/31mbar – fr off-resonance
- Pressure on 2K circuit up to 4,0bar
- Cavity for 1/2h under pressure
 - during this time the pressure go up to 6,1bar
- No increase of pressure or leak rate
 - higher leak rate due to surface desorption – no leak!
- Pressure on 2K circuit down to 1,0bar
 - Frequency and field flatness checked at different pressures
 - Frequency identical at 1,0bar before and after the pressure test.
 - No impact at the filed flatness
 - No plastic deformation at the Cavity, Tunersystem or He-Vessel
